DEPARTMENT OF TRANSPORTATION

Quality Assurance and Source Inspection

Contract #: 04-0120F4Cty: SF/ALA Rte: 80 PM: 13.2/13.9File #: 69.28**WELDING INSPECTION REPORT****Resident Engineer:** Pursell, Gary**Address:** 333 Burma Road**City:** Oakland, CA 94607**Report No:** WIR-010597**Date Inspected:** 17-Oct-2009**Project Name:** SAS Superstructure**OSM Arrival Time:** 700**Prime Contractor:** American Bridge/Fluor Enterprises, a JV**OSM Departure Time:** 1900**Contractor:** Zhenhua Port Machinery Company, Ltd (ZPMC), Changxing Island **Location:** Shanghai**CWI Name:** ZPMC and ABF**CWI Present:** Yes No**Inspected CWI report:** Yes No N/A**Rod Oven in Use:** Yes No N/A**Electrode to specification:** Yes No N/A**Weld Procedures Followed:** Yes No N/A**Qualified Welders:** Yes No N/A**Verified Joint Fit-up:** Yes No N/A**Approved Drawings:** Yes No N/A**Approved WPS:** Yes No N/A**Delayed / Cancelled:** Yes No N/A**Bridge No:** 34-0006**Component:** OBG**Summary of Items Observed:**

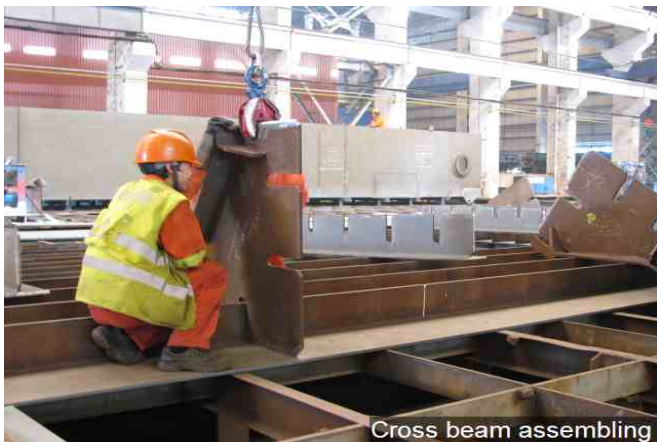
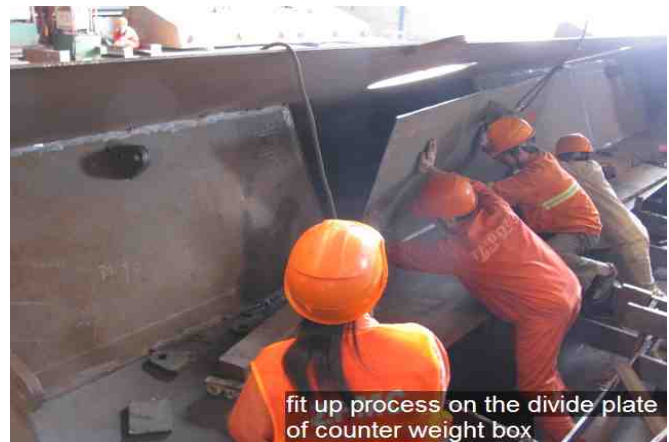
Counter weight: - Caltrans QA inspector observed two ZPMC workers and one welder performed fit up and SMAW tack weld process on the divide plate of counter weight box #90. A numerous temporary tack welds have been welded attach to the divide plate after adjusted and secured by hand jack. The fit up and SMAW tack welding process were monitored and recorded by ZPMC and ABF QC inspector. Base on Caltrans QAI observation, no discrepancies were noted.

Counter weight: - Caltrans QA inspector observed a ZPMC welder performed FCAW CJP process on base plate of counter weight component #84. The FCAW CJP process was monitored and recorded by ZPMC and ABF QC inspector. Based on Caltrans QA Inspector observations, no discrepancies were noted.

Counter weight: - Caltrans QA inspector observed four ZPMC workers and one welder performed fit up and SMAW tack weld process on the divide plate of counter weight component #54. A numerous temporary tack welds have been welded attach to the divide plate after adjusted and secured by hand jack. Base on Caltrans QAI observation, no discrepancies were noted.

Longitudinal diaphragm: - Caltrans QA Inspector observed two ZPMC welders performed FCAW fillet weld

process on five longitudinal diaphragms. The longitudinal diaphragms ID are LD003-60-004, LD-002-049-004, LD003-059-004, LD004-060-004 and LD004-059-004. The fillet weld is designed T-joint with size 6mm weld in 2F position. The FCAW process were monitored and recorded by ZPMC and ABF QC inspector. Based on Caltrans QA Inspector observations, no discrepancies were noted.

Cross beam: - Caltrans QA inspector observed two ZPMC workers and one tack weld welder performed fit up and SMAW tack weld process on the corner plates of cross beam plate #FB202A. A numerous temporary tack welds have been welded attach to the corner plates after adjusted and secured by hand jack. The fit up and SMAW tack welding process were monitored and recorded by ZPMC and ABF QC inspector. Base on Caltrans QAI observation, no discrepancies were noted.

Tower strut: - Caltrans QA Inspector observed two welders performed SMAW noncritical weld repair process on tower strut. The tower strut weld ID is WD1-A305-77M-1-10A/B. The SMAW noncritical repair weld located at web to flange which has been rejected by ZPMC UT testing. The weld repair report number for noncritical is TWR-2411. The SMAW noncritical weld repair is monitored and recorded by ZPMC and ABF QC inspector. Based on Caltrans QA inspector observations, no discrepancies were noted.
